REMEDIATION OF SKARES BRICKWORKS & WHITEHILL COLLIERY

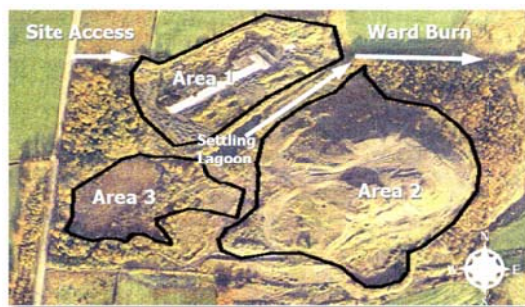
Figure 1: Site areas before redevelopment

- **Area 1:** The former Skares brickworks, approximately 3 hectares, was operational from the late nineteenth century until 1962.
- **Area 2:** A spoil heap arising from the dismantled Whitehill Colliery which closed in 1963.
- **Area 3:** Former agricultural land and woodland degraded by flooding from spoil heap water run-off.

The site characterisation work identified spoil heap (Area 2) water run-off had been directed to the settling lagoon prior to discharging via a ditch and outfall to Ward Burn off-site, see Figure 1. Lack of maintenance since colliery closure led to silting, and overflow. As a result a second lagoon and marshy wetland (Area 3) became established to the south.

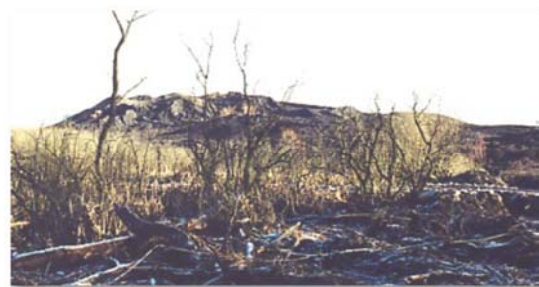
Trees had colonised some parts of the spoil heap, however the lack of nitrogen and phosphorous in the soil reduced the growth rate and prevented natural seeding, see Figure 2 below.

Figure 2: Fifteen year old tree with stunted growth

The Site Investigation confirmed that vegetative matter should be incorporated into the spoil heap in an effort to stabilise the loose slag and blaes material eroding into the settling lagoon. It was proposed that organic matter such as sewage sludge cake should be used to condition the nutrient deficient slag and blaes to create a growing medium capable of sustaining plant life.

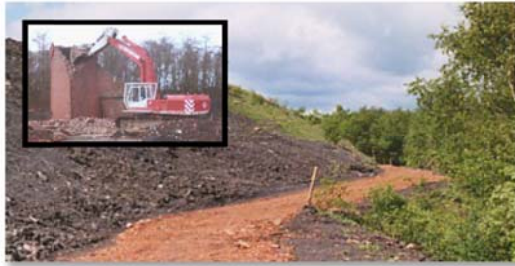
Work began with the demolition of the old brickworks building. The brick and concrete was crushed and used to form the paths and viewpoints which pedestrians will use after completion of the VMSR regeneration programme, see Figure 3. Representatives of the local communities were encouraged to visit and view the operations under proper supervision.

Figure 3: Demolition of Brickworks & Construction of Paths

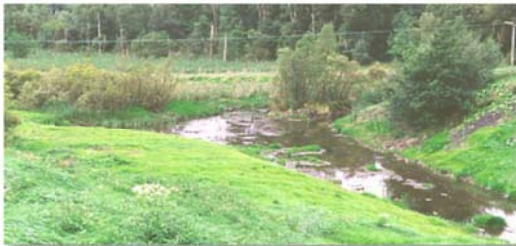
The silted settling pond and outlet was excavated to the clay beds. This process increased the capacity to store surface water run-off and immediately alleviated the flooding in Area 3, shown in background of Figure 4.

Figure 4: Dredged Settling Lagoon, Drained Area 3

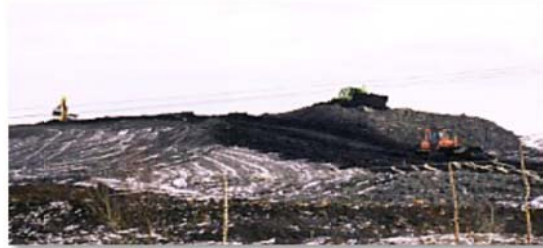
The field trials identified that the VMSR method could be used to remediate the site with an optimum design mix of 3:1 of blaes/shale to sewage sludge cake respectively to a suitable rooting depth. Full scale soil remediation and contour formation took place from August 2000— February 2002.

Figure 5: Shaping of Contours

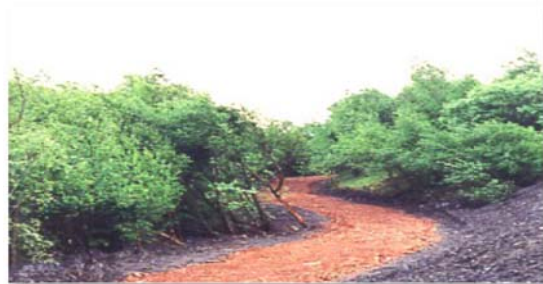
Flooding has also been eliminated due to the improved drainage on site. To sustain this, mixed woodland and grass was planted over the entire site thereby reducing soil run-off and lagoon silting, see Figure 6. The regenerated woodland and wetland is now a rich habitat for a range of animals and birds.

Figure 6: Tree Planting Completes the Site Regeneration.
